CITY OF BALTIMORE WET WEATHER CONSENT DECREE SMOKE AND DYED WATER TESTING FORM		Page 1 of 4
Sewershed: Low Level Subsewershed: 44	Company: REI/DRAYCO	Date: 08/25/2008
Test Type: Smoke	Ground Condition: Dry: X Damp: _ Wet: _	Supervisor: E.R. Crew: 03
Manhole ID: S17K__034MH	Test ID: 1029-553	Notifications Made: __X__ Residents, Fire, 311
Field Sketch: (Show all manholes with numbers, blower placement location, sandbag or isolation locations, street names, building addresses and locations, defect locations and photograph numbers)

CITY OF BALTIMORE
SMOKE TESTING OBSERVATION SUMMARY
LOW LEVEL SEWERSHED
BALTIMORE CITY PROJECT 1029
REI/DRAYCO

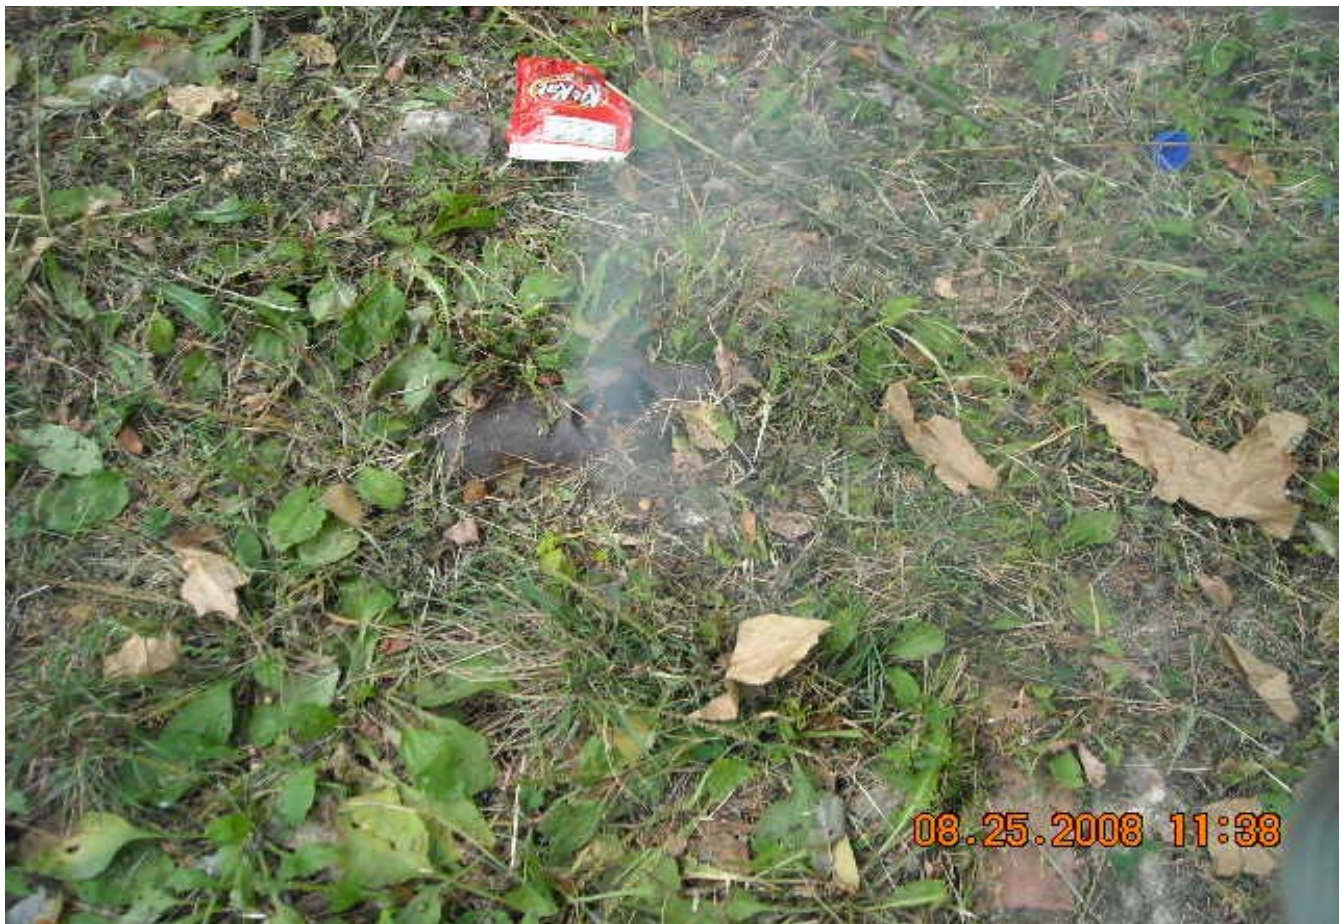
Photograph No: OB01-01
Filename: 1029-553_OB01-01.jpg

Unique Test ID: 553	Date: 08/25/2008	Basin: LL - 44	Manhole ID: S17K__034MH
Defect No: OB01	Supervisor: E.R.	Crew: 03	Dye Test Recommended: N
Location: 2420 FREDERICK AVE.			
Source Type: 02 Service Line		Sector: 01 Public	
Location: 11 Field/Woods		Severity: 03 Moderate	Drainage Area: 2
Comments: SMOKE COMING FROM DAMAGED AND ABANDONED SERVICE LINE AT GRADE ACROSS ALLEY FROM REAR OF 2420 FREDERICK AVE.

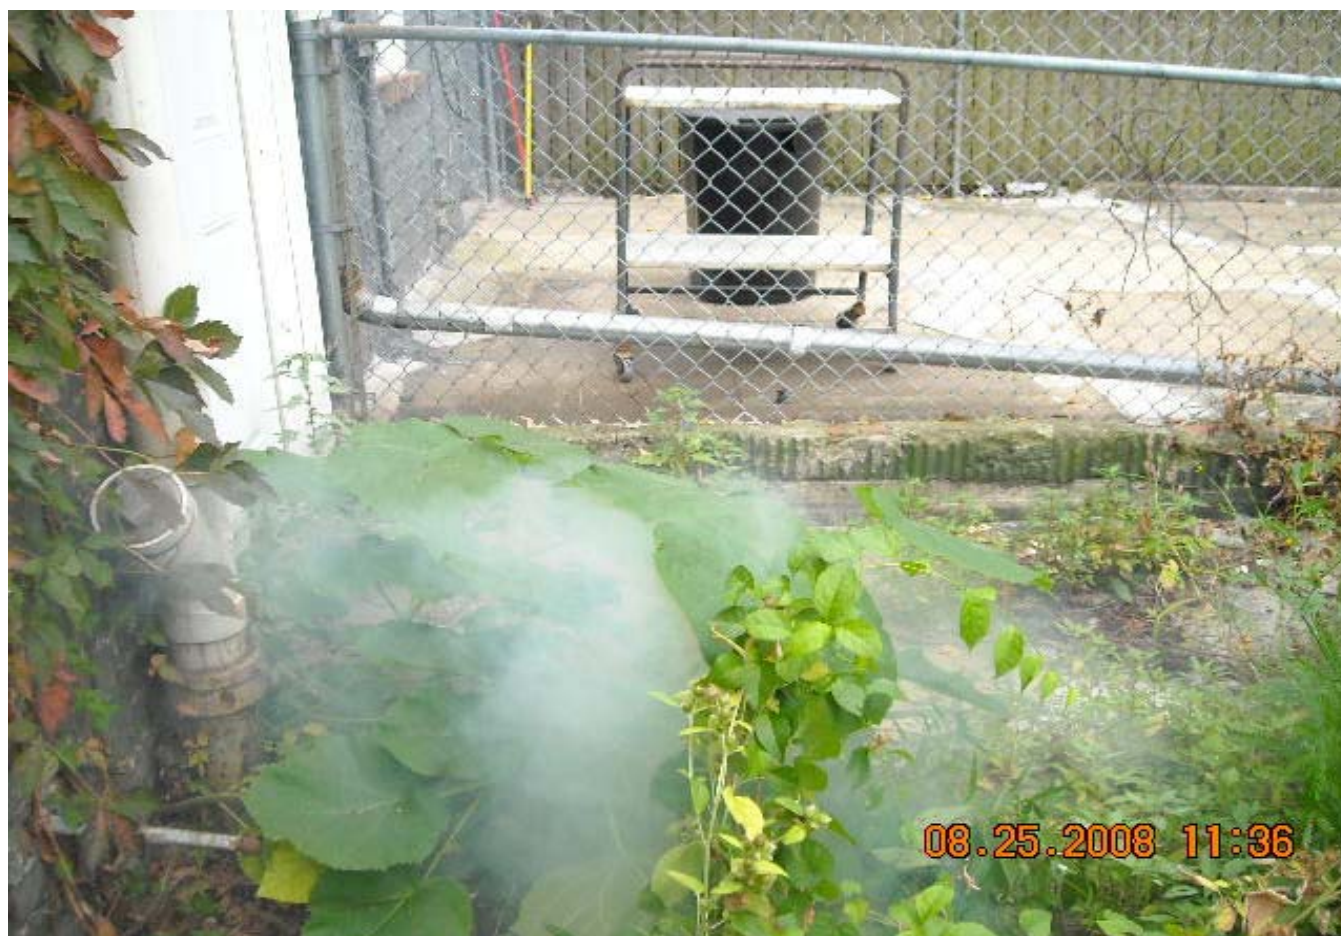
Photograph No: OB02-01
Filename: 1029-553_OB02-01.jpg

Unique Test ID: 553	Date: 08/25/2008	Basin: LL - 44	Manhole ID: S17K__034MH
Defect No: OB02	Supervisor: E.R.	Crew: 03	Dye Test Recommended: N
Location: 2442 FREDERICK AVE.			
Source Type: 02 Service Line		Sector: 02 Private	
Location: 08 Yard - Back		Severity: 03 Moderate	Drainage Area: 10
Comments: SMOKE COMING FROM GROUND AREA NEAR CLEANOUT AT RESIDENCE.
